SJ Light House Update

Outside of Outer light St. Joseph Michigan North Pier

NCP Coatings Inc.

Products Utilized on the St. Joseph Michigan North Pier Lighthouse Project

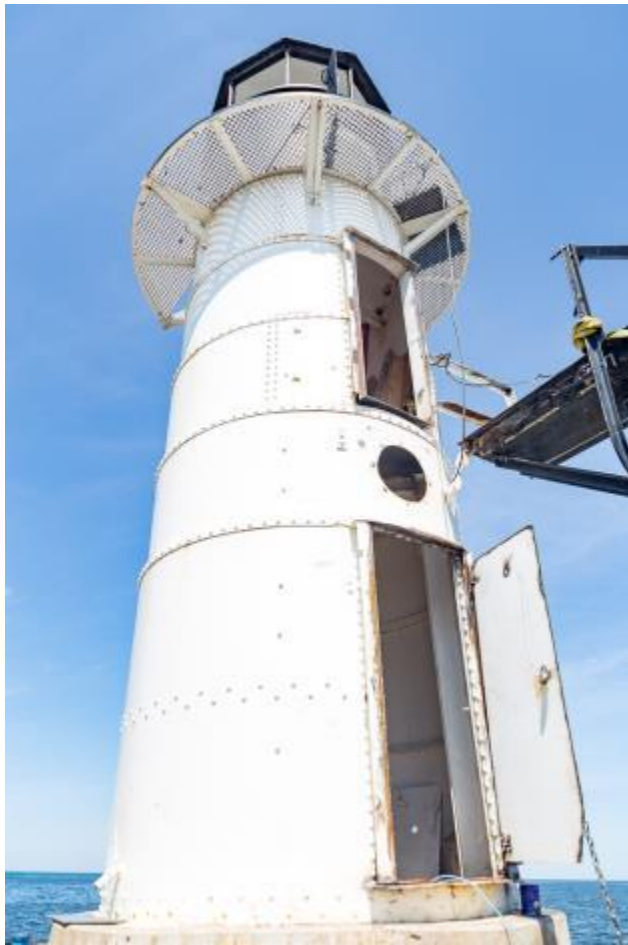
Prior to NCP SiloxoSheild 2K

The Lighthouse components were first blasted to bare steel, repaired as required and then coated with the following NCP Coatings Inc. system. This system of paint coatings was designed to provide a long lasting protective coating surface for generations to come.

- **1st. Coat: N-6966A/B, Zinc Rich Epoxy Primer, MIL-DTL-24441D Formula 159**
- **2nd. Coat: N-6237A/B, Epoxy Polyamide Intermediate Primer, MIL-DTL-24441D Type III Formula 150**
- **3rd. Coat: NCP Coatings new SiloxoShield 2K polysiloxane technologies developed jointly with Naval Research Laboratories**

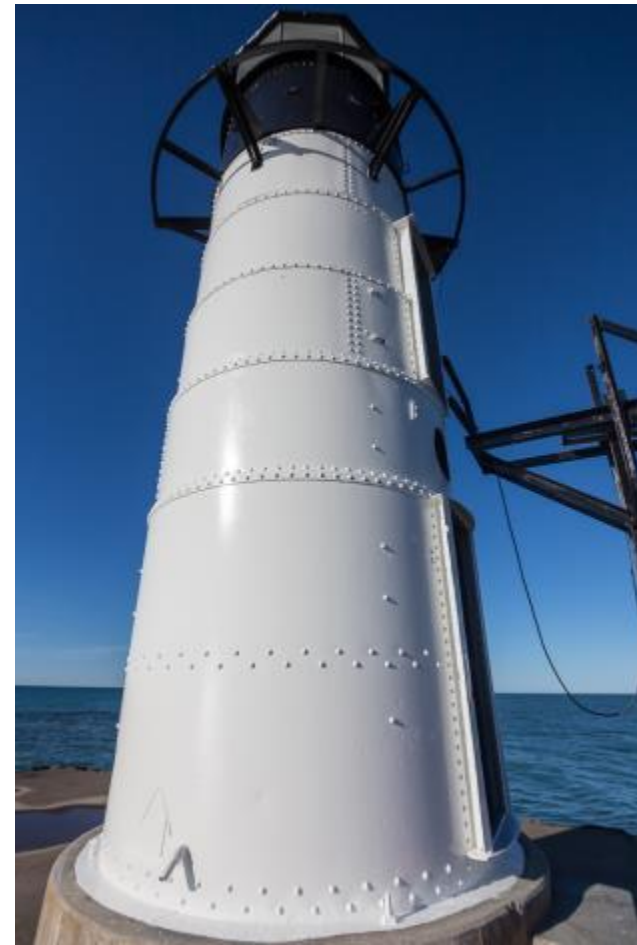
Post NCP SiloxoSheild 2K

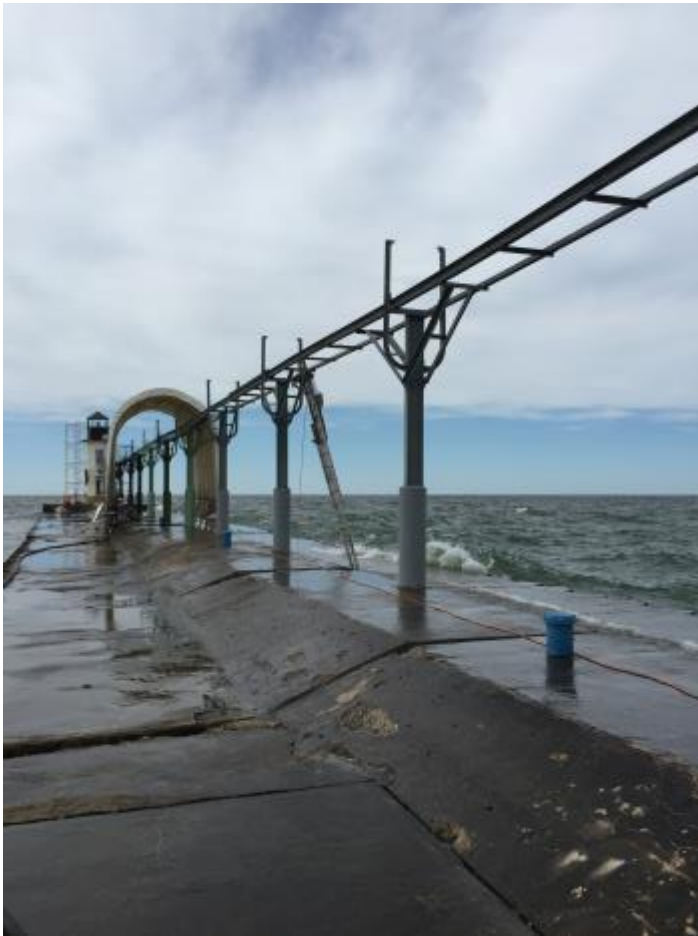
Catwalks at St. Joseph Michigan North Pier

Prior to NCP SiloxoSheild 2K

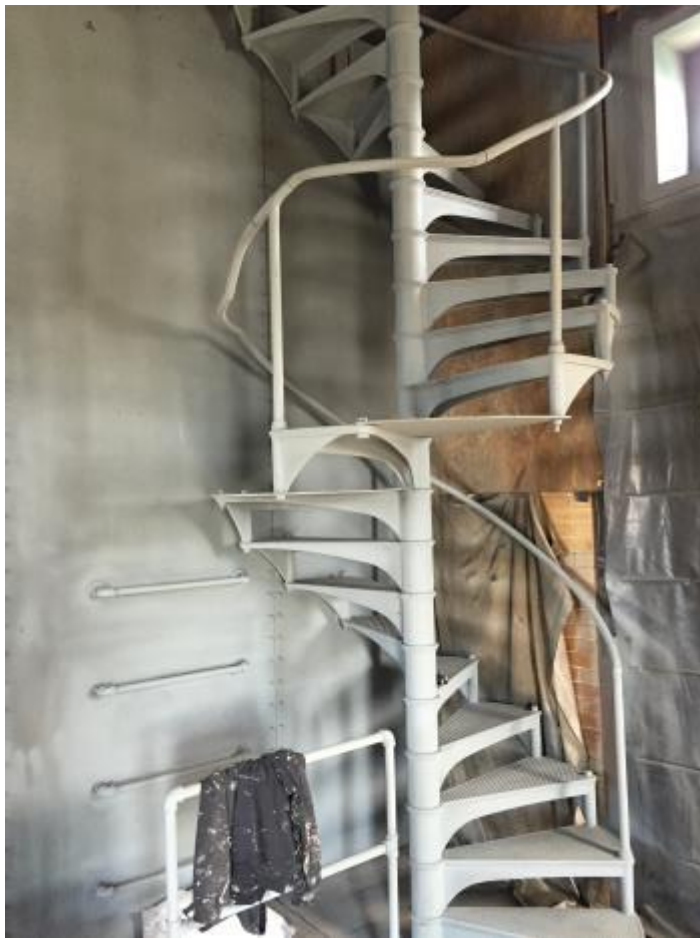
Inside of Inner lighthouse St. Joseph Michigan North Pier

Inside Staircase prior NCP
SiloxoSheild 2K

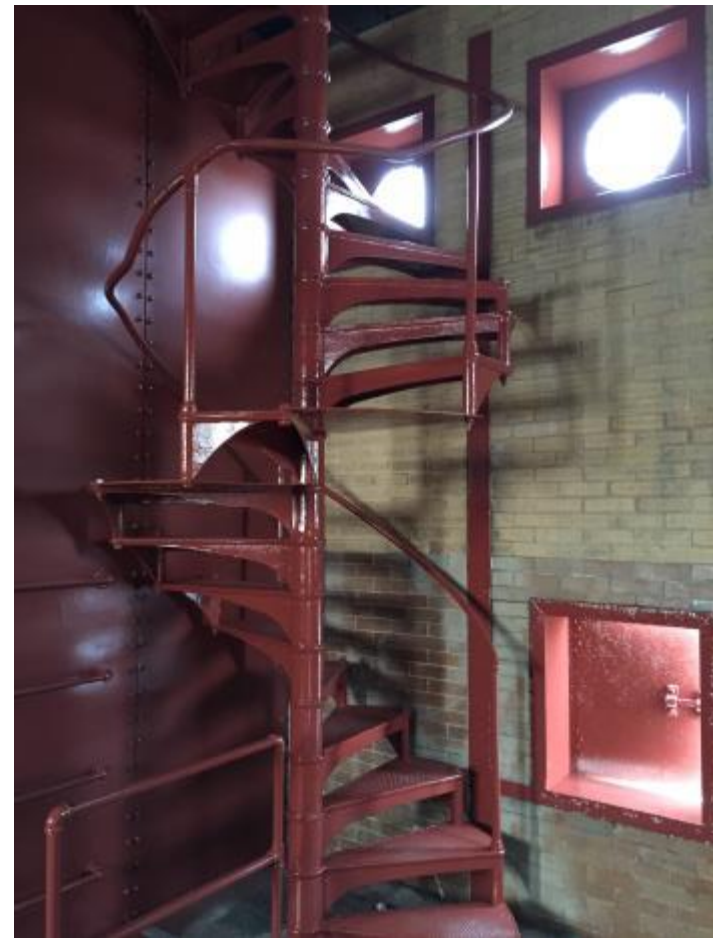
Inside Staircase Post NCP
SiloxoSheild 2K

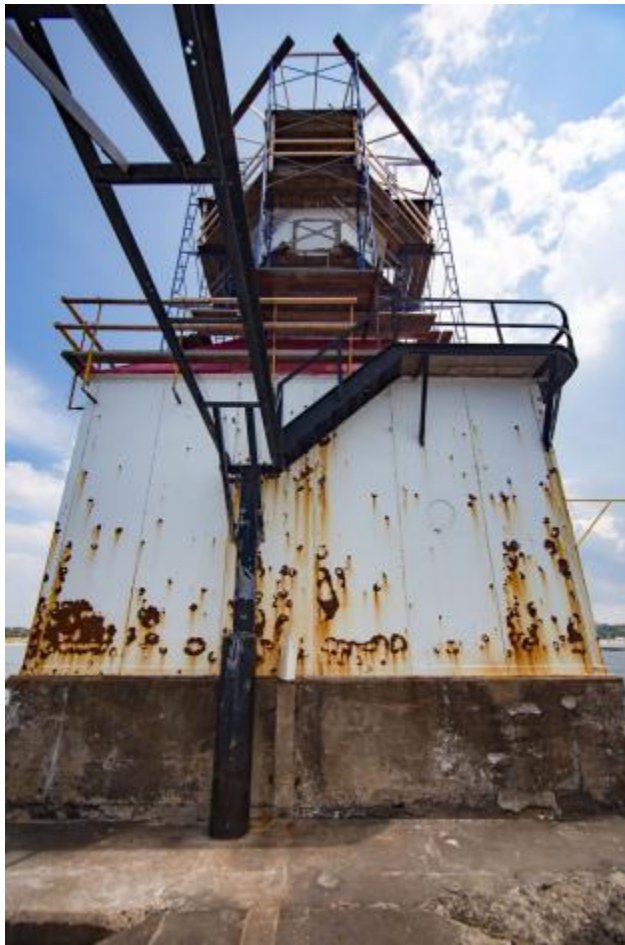
Outside of Inner lighthouse St. Joseph Michigan North Pier

Prior to NCP SiloxoShield 2K
